A mining research contract report
APRIL 1983

STUDY OF STABILITY PROBLEMS AND HAZARD EVALUATION IN THE MISSOURI PORTION OF THE TRI-STATE MINING AREA

Contract J0100132
Missouri Department of Natural Resources
Division of Geology and Land Survey

BUREAU OF MINES
UNITED STATES DEPARTMENT OF THE INTERIOR

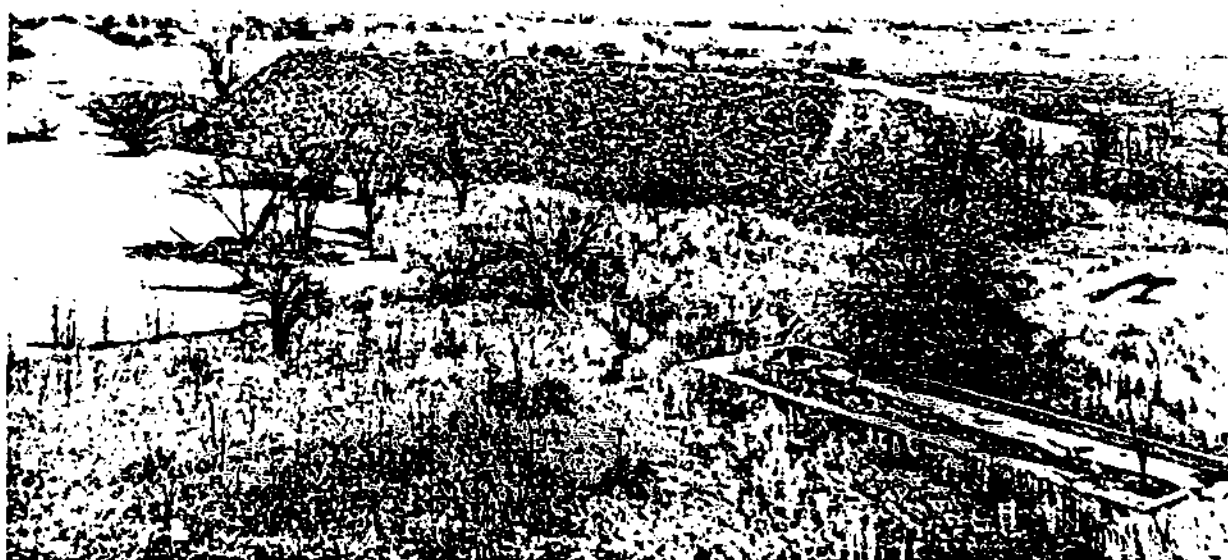
FIGURE 4. - Mine waste pile, containing chats and boulders.

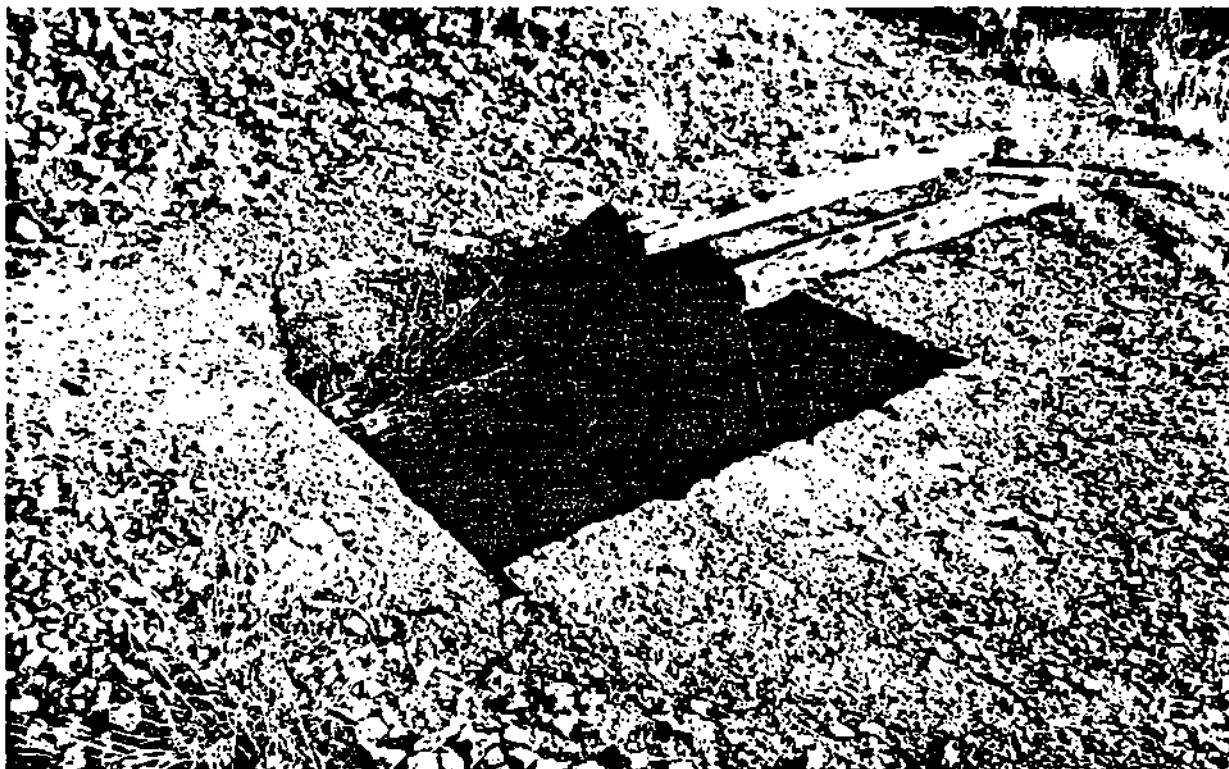
FIGURE 7. — Open shaft with intact concrete collar.

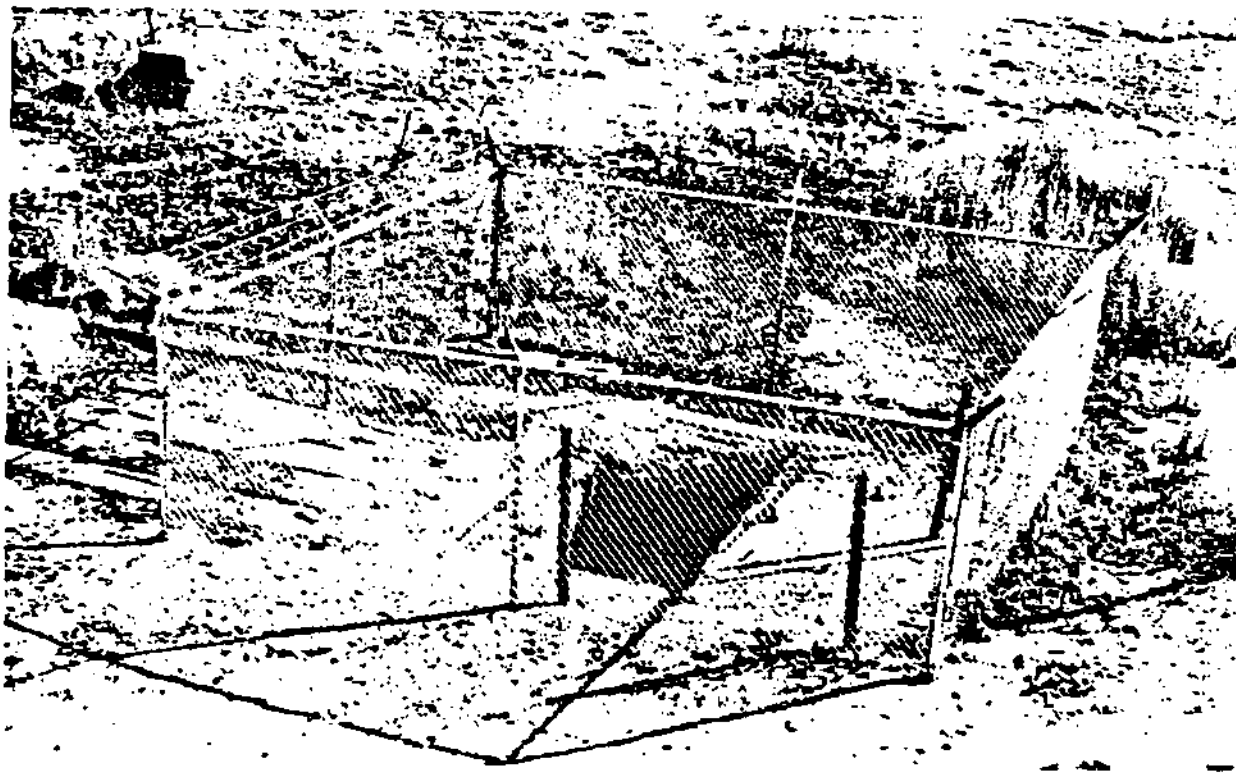
FIGURE 17. — Open shaft, safeguarded with metal fencing.

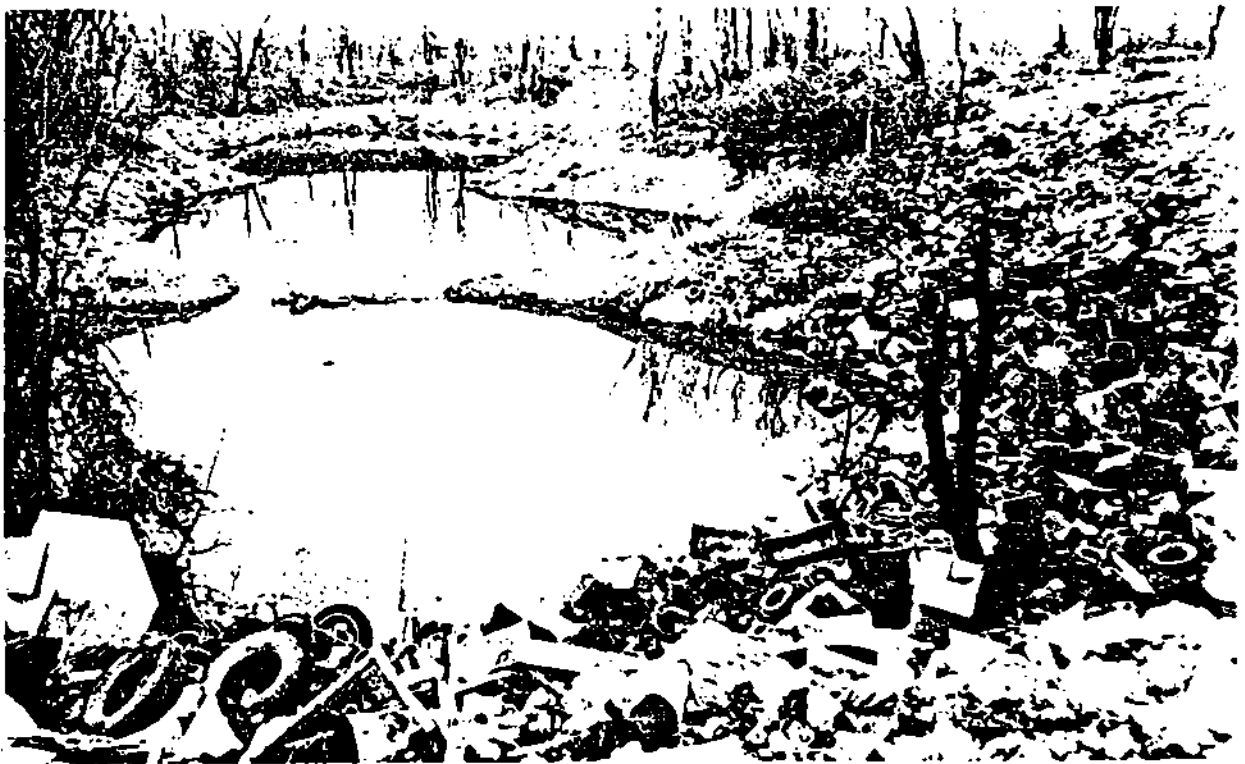
FIGURE 19. — Subsidence pit, filled with water and rubbish.

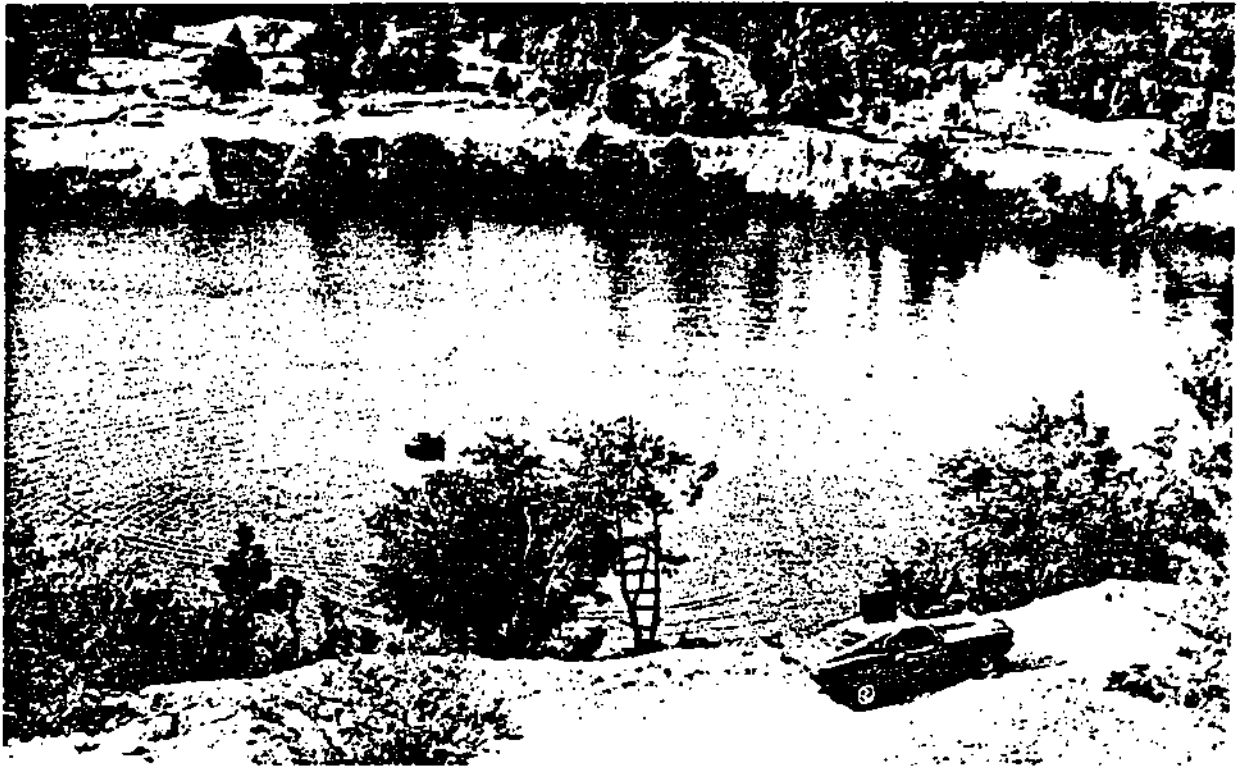
FIGURE 20. — Open pit, filled with water and used as recreational area.

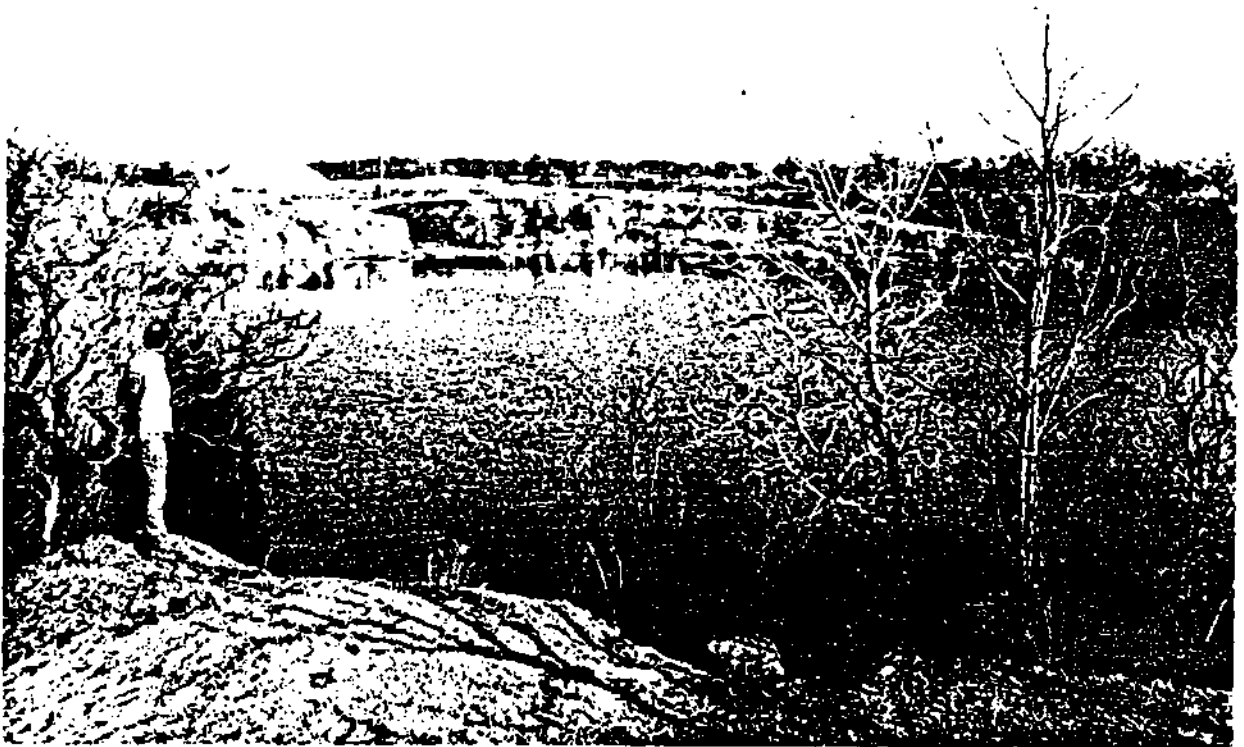
FIGURE 21. — Oronogo Circle, famous open pit, now filled with water.

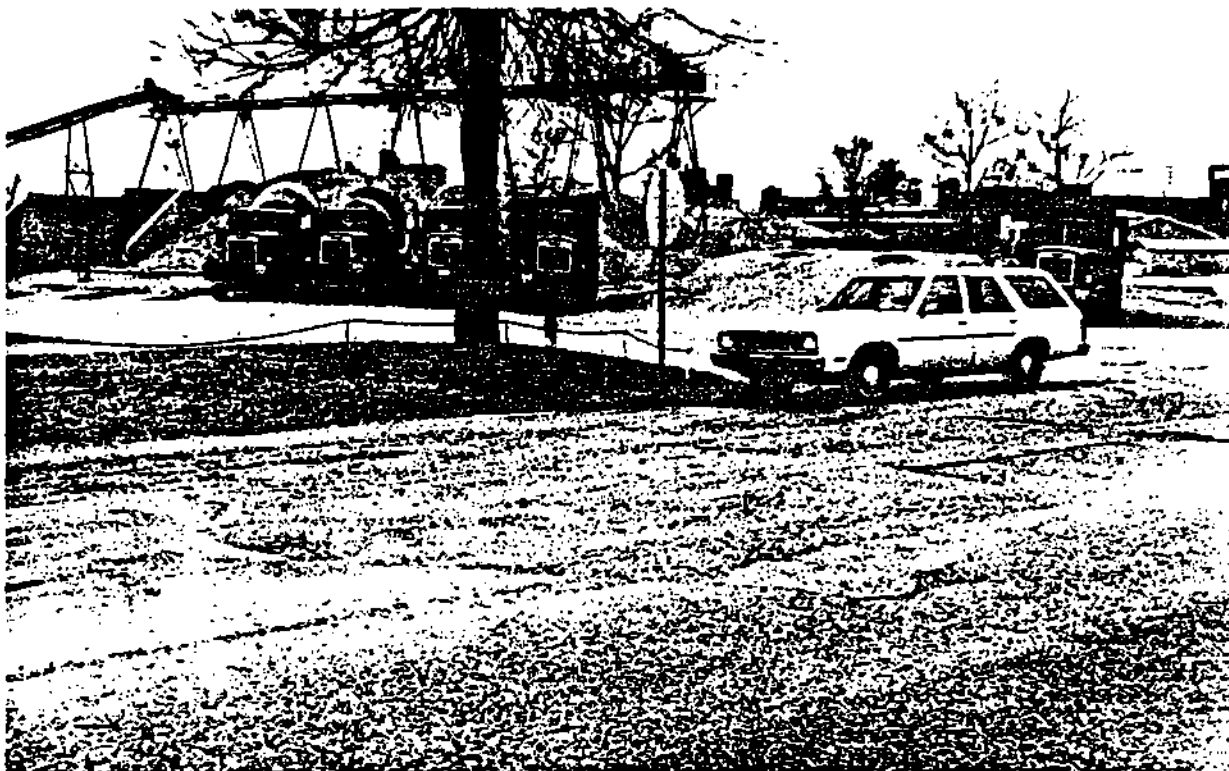
FIGURE 22. — Repaired subsidence in roadbed, Murphy and 5th Streets, Joplin.

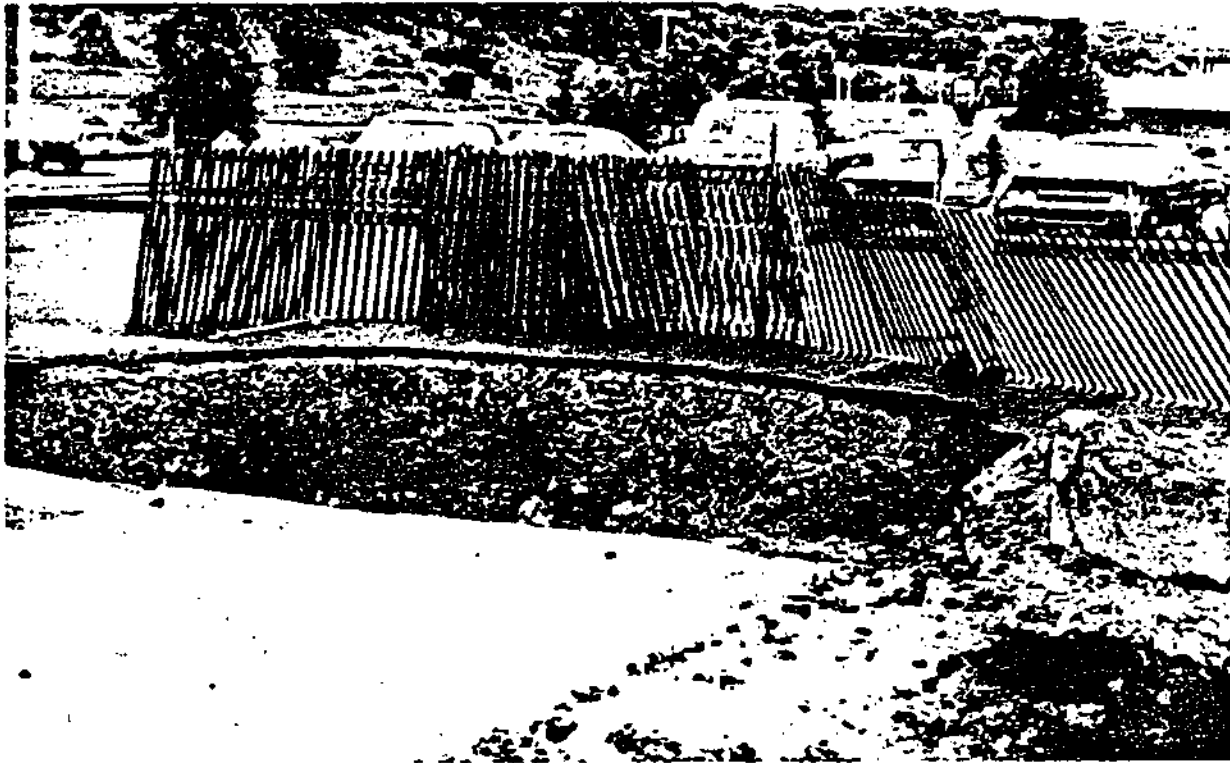
subsidence occurred on June 1, 1982, in the parking lot of the St. John's Regional Medical Center (site number 27-33-15-3). The resulting hole was 20 m (60 ft) deep and filled with water to within 6 m (20 ft) of the surface. The oval-shaped surface outline, measuring 3 x 6 m (10 x 20 ft), is shown in figure 24. A fill of rock and concrete mix has temporarily sealed the opening at this site (fig. 25). It is apparent that this area holds a high potential for future, subsidence-related problems.

FIGURE 24. — Subsidence in parking lot at St. John's Regional Medical Center, Joplin.

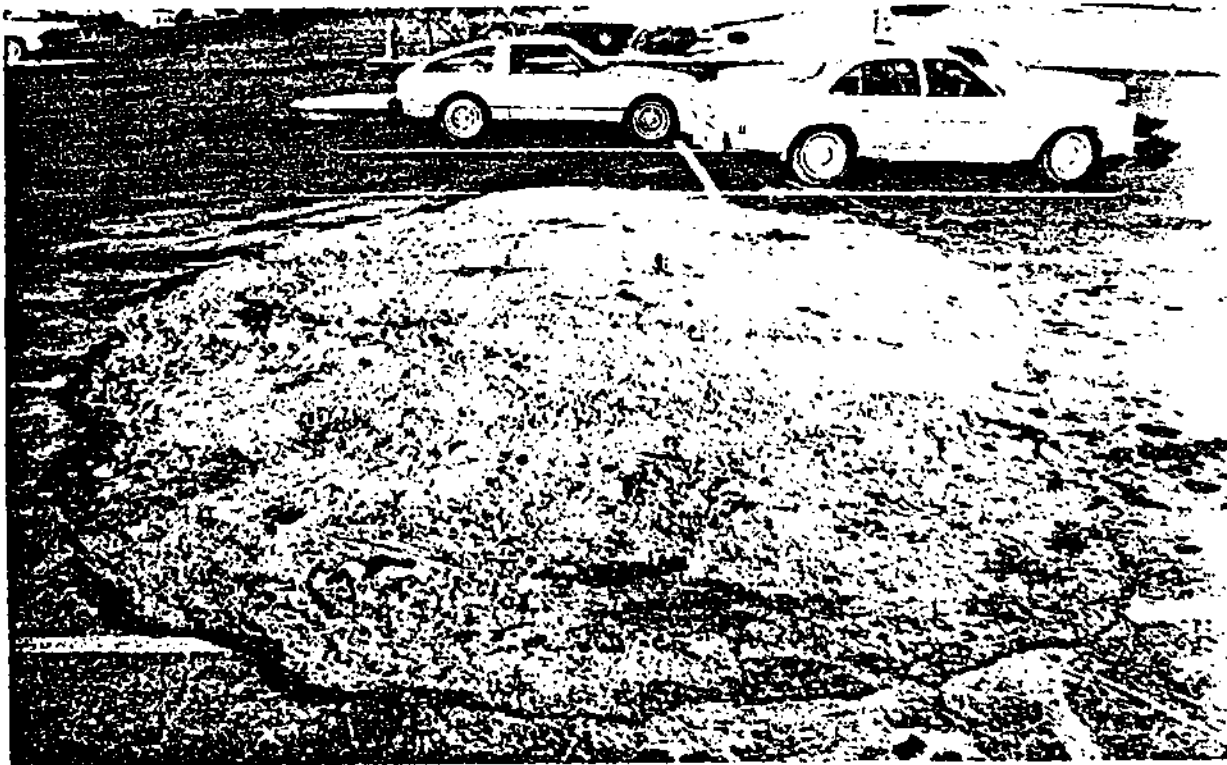
FIGURE 25. — Repaired subsidence in parking lot at St. John's Regional Medical Center, Joplin.

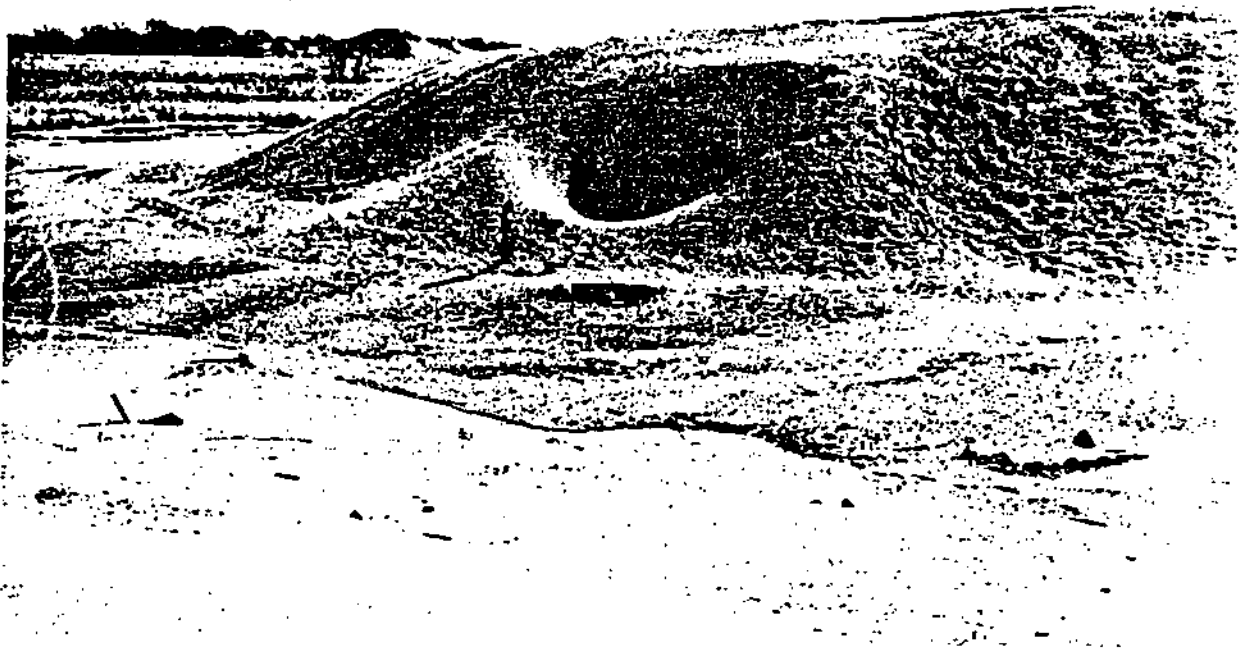
FIGURE 26. — Collapsed area within chat pile.

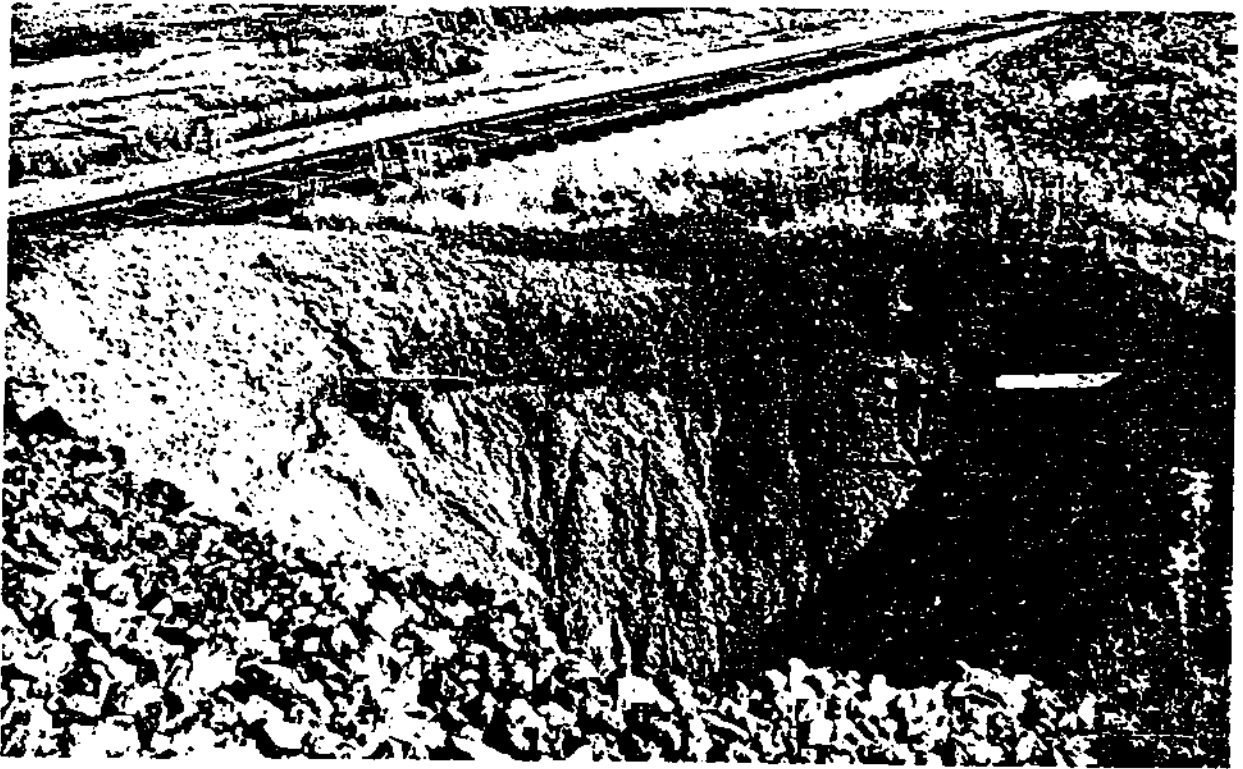
FIGURE 27. — Collapse at top of open shaft, encroaching on railroad.
